**TRAFFIC ENGINEERING
STUDY OF W. BENDER
ROAD BETWEEN MILWAUKEE
RIVER PARKWAY AND
JEAN-NICOLET ROAD IN
THE CITY OF GLENDALE**

**SOUTHEASTERN WISCONSIN
REGIONAL PLANNING COMMISSION**

**MEMORANDUM REPORT
NUMBER 95**

August 1994

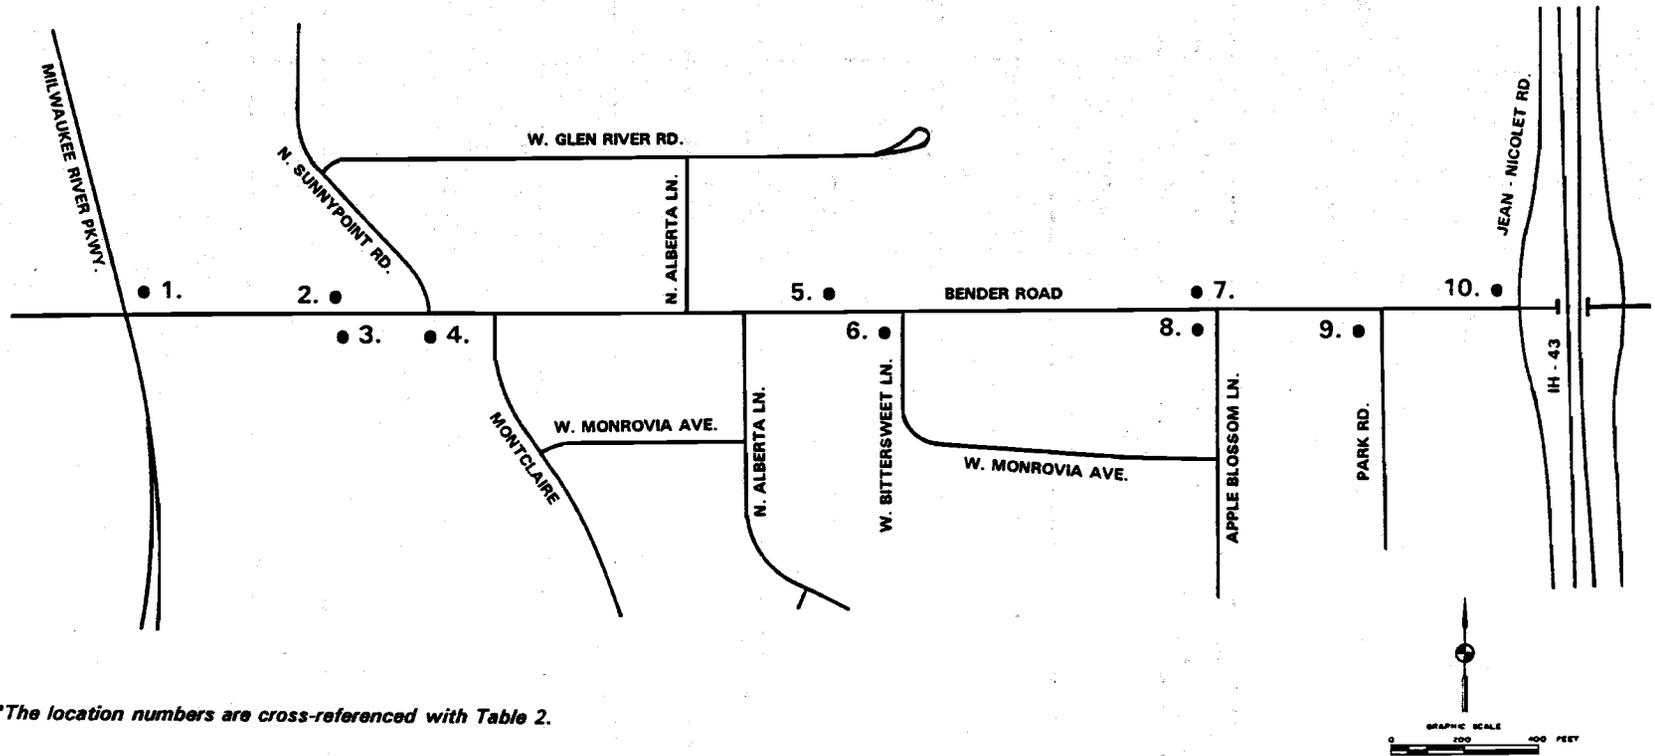
Map 3

The Commission staff conducted an inventory of the existing traffic signs along the W. Bender Road study segment. A total of fourteen signs were found posted at ten locations: eight regulatory signs, three advance warning signs of traffic control, two guide signs, and one supplementary sign. Analyses of the sign data inventory data indicated that the multiple stop signs mounted on a single post on the east- and westbound approaches to W. Bender Road intersection with Milwaukee River Parkway serve no useful purpose and should therefore be considered inappropriate.

At the intersection, each of the W. Bender Road approaches have two stop signs and a four-way supplementary sign; all placed on a single sign post. The posting of duplicate signs on the same post is inappropriate and serves no useful purpose. It was also recommended that the redundant 24 inch in diameter stop sign be removed from the eastbound and westbound approaches at the intersection of W. Bender Road and Milwaukee River Parkway.

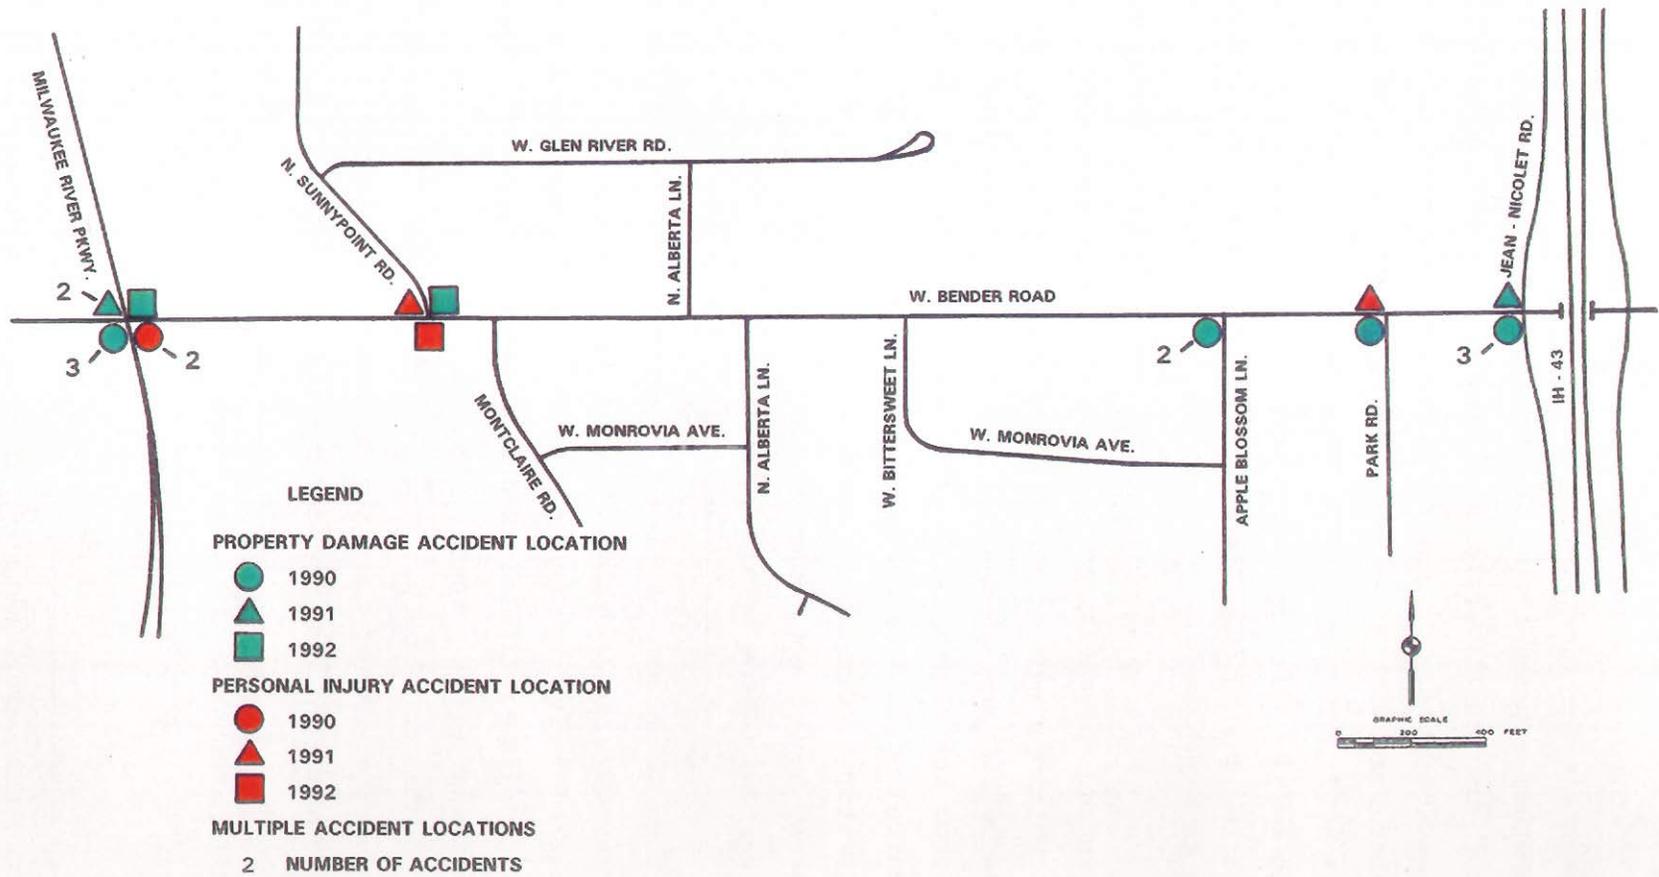
Map 4

All of the 19 total accidents reported occurred at intersections along the study segment.¹ The locations of the motor vehicle accidents which have occurred on the study segment during the past three years are shown on Map 4. As shown on Map 4, the traffic accidents occurred along much of the study segment. However, it may be noted that the accidents are concentrated at the intersections of W. Bender Road with Milwaukee River Parkway, Sunnypoint Road, Appleblossom Lane, Park Road, and Jean-Nicolet Road. Figure 2 contains the collision diagrams for each of the intersections along the study segment that experienced accidents reported during the three year period analyzed by the Commission staff.

Motor vehicle accident histories for the study segment of W. Bender Road were inventoried for the time period of January 1, 1990 through December 31, 1992. A total of 19 accidents were reported on the study segment during this period with the number of accidents decreasing slightly in each consecutive 12-month period. Of the 19 total accidents, five involved personal injuries and the remaining 14 involved property damage only. There were no accidents involving fatalities. Because of the concentration of accidents at two locations--the intersections of W. Bender Road with Milwaukee River Parkway with eight accidents and W. Bender Road with Jean-Nicolet Road with four accidents--the two locations were reviewed to determine if any accident pattern exists which may indicate a potential traffic safety problem at these locations. No other significant patterns with respect to time or nature of accident were observed.

It is recommended that the incidence of accidents and the type of accidents be closely monitored and the installation of stop sign beacons be reconsidered if the incidence of accidents, and particularly right angle collisions, increases.

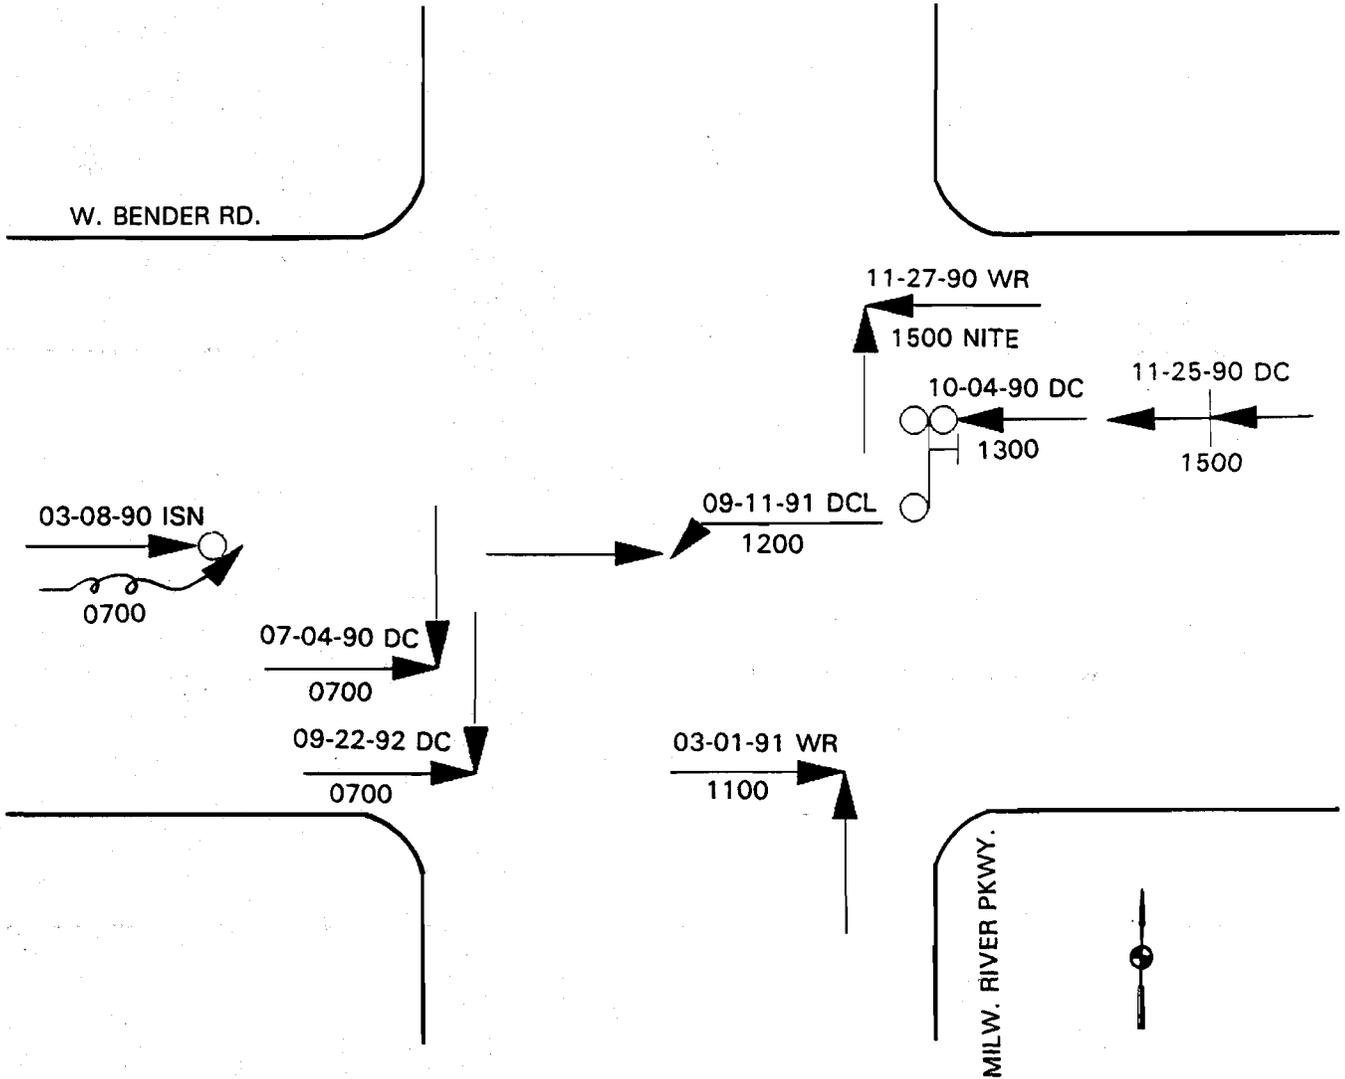
Figure 2

to a lower number of accidents in the years following; however, further analyses of the three accidents subsequent to the change in traffic control revealed a pattern of motorists disregarding the stop signs. This trend may indicate a lack of or deficiency in the advance warning of the intersection's stop signs. Advance warning signs are located on both approaches of W. Bender Road approximately 580 feet before the intersection notifying motorists of the stop ahead. However, the Manual On Uniform Traffic Control Devices recommends that the distance for placement of similar stop condition warning signs be 400 feet in advance of the stop condition based upon the 85th percentile speed of about 33 miles per hour. Therefore, it was recommended by the Commission staff that advisory distance plates be added to the "STOP AHEAD" advance warning signs on the eastbound and westbound approaches to the W. Bender Road and Milwaukee River Parkway intersection.

Also considered but rejected was the installation of stop sign beacons on the east- and westbound approaches to the W. Bender Road intersection with Milwaukee River Parkway. The advantage of this action is improved driver awareness of the stop signs. While there are no disadvantages to this action, the number of accidents occurring at this intersection does not warrant such an installation. Thus, this action is not recommended for implementation.
